Imperial Oil

2006 k 5
Casing Integrity Report.

Re: 2006 Annual Casing Integrity Report

2006 Annual Casing Integrity Report

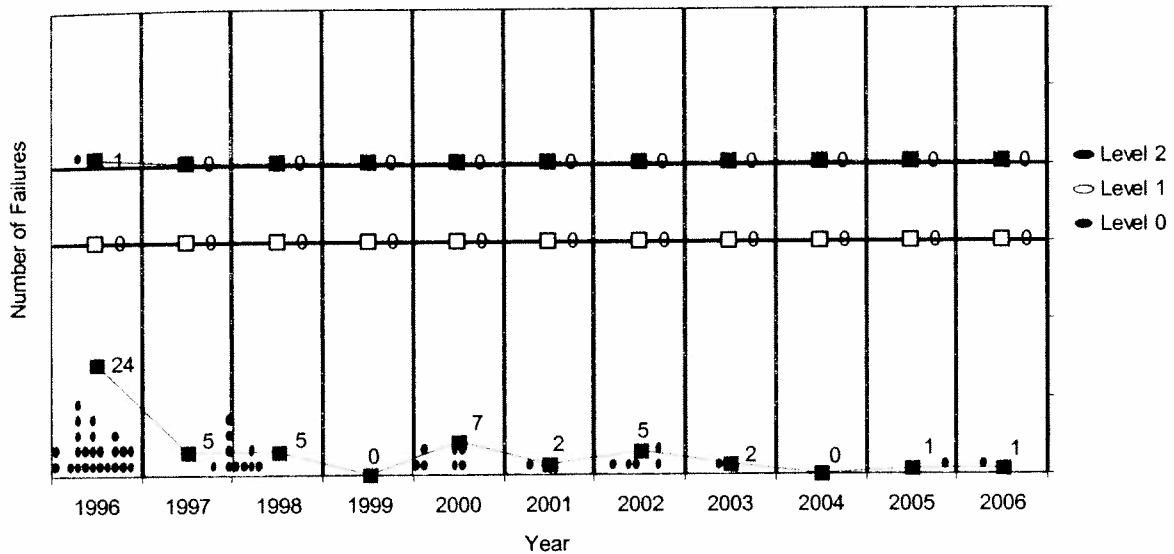
Figure 1: Cold Lake Surface Failures by Consequence Level

Historic consequence levels associated with near surface casing failures since 1996 are displayed in Figure 1. All near surface failures, except H01-03 (1996), were assessed at a Level 0 environmental consequence, including the near surface failure in 2006 at J03-20 (detected during a pre-steam casing integrity check resulting in negligible environmental impact). As highlighted in previous annual reports, the H01-03 surface failure that occurred in 1996 was assessed at a Level 2 consequence due to an estimated fluid release of 4700 m³ at surface.

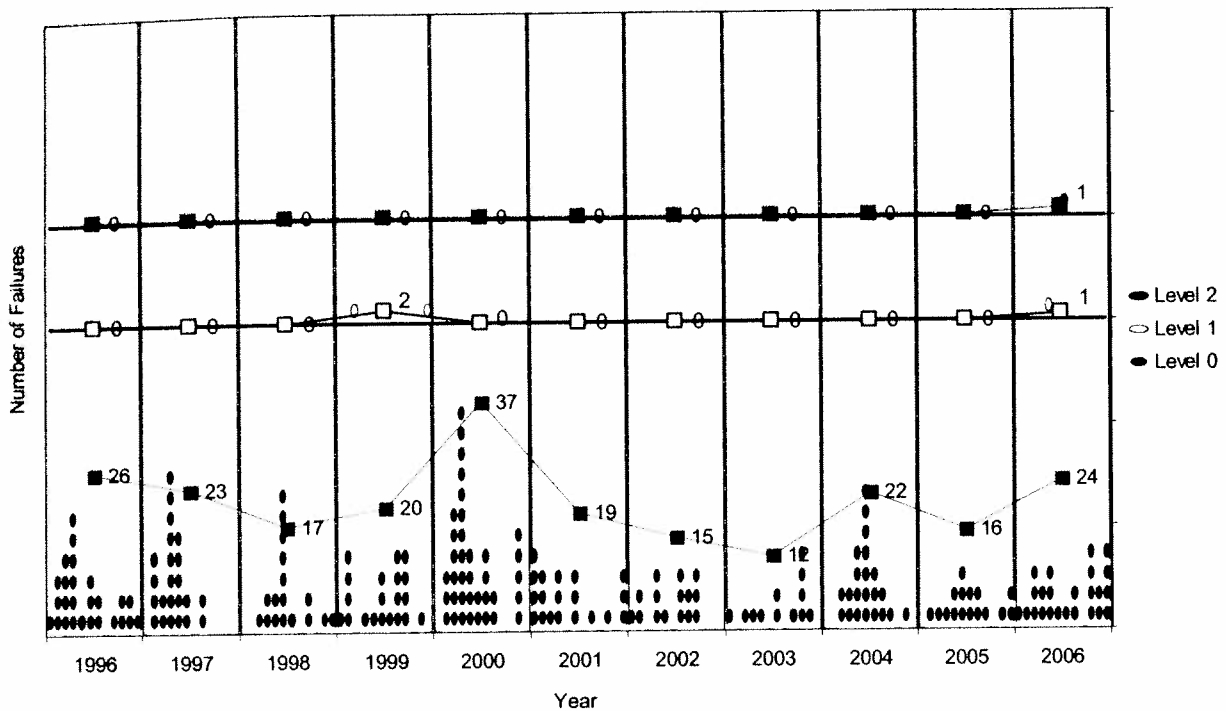
Figure 2: Cold Lake Intermediate Failures by Consequence Level

Historic consequence levels associated with intermediate casing failures since 1996 are displayed in Figure 2. Two (of the 26) intermediate failures that occurred in 2006 were assessed at higher than Level 0 environmental consequence.

The T09-01 intermediate casing failure detected in May, 2006 was assessed at a Level 1 consequence due to resulting fluid loss into the bedrock that was above the threshold to cause a multi-well failure. It was estimated that the primary failure, T09-01, released 6000 m³ fluid (primarily steam) into the Colorado group, which resulted in the secondary intermediate failure at T09-07. T09-07 released an estimated 900 m³ fluid (primarily produced water) therefore was assessed at a Level 0 consequence since fluid loss was less than 1000 m³. Since both releases were contained within the Colorado group, no adverse environmental impact was deemed to occur.

The H39-H04 failure detected in July, 2006 was assessed at a Level 2 environmental consequence due to aquifer contact. It was estimated that H39-H04 released 3200 – 5400 m³ produced fluid (approximately 25% bitumen) into the Glacial Till. A summary of the actions taken in the delineation, quantification, evaluation, and remediation stages of Imperial Oil's incident response was summarized in the H39-H04 Casing Failure Investigation letter submitted to AENV and the EUB on December 19, 2006.

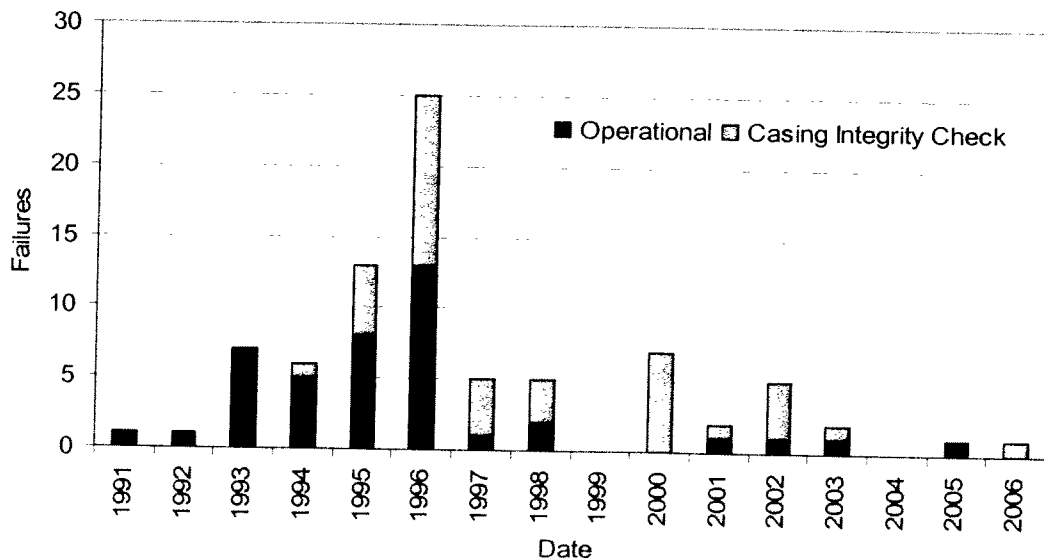
Figure 3: Commercial Surface Failures by Year

The primary mechanism for near surface casing failures is external corrosion. Minor wellhead packing leaks and surface water run-off collect in the conductor - production casing annulus forming a corrosion cell. Water typically accumulates in the conductor annulus due to cement slumping (after primary cementing) or cement degradation over time.

The number of commercial surface failures by year in Cold Lake is displayed in Figure 3. Since 1991, 81 commercial wells have failed in the top 25m of the wellbore, including the surface failure detected at J03-20 in 2006 during a pre-steam casing integrity check. Details on this failure are shown in Table 2. The peak failure rate in 1996 corresponds to failures identified through pre-steam casing integrity checks implemented as part of the casing integrity program. In addition, a further 107 wells have either been proactively repaired or taken out of steam service due to excessive wall loss. It can be seen from Figure 3 that the number of near surface failures has been reduced significantly since 1996, indicating the effectiveness of Cold Lake's cementing, top-up, and casing integrity operating practices. These existing operating practices have also been successful in selectively removing damaged wells from active operations.

Corrosion inspection logs (electromagnetic flux leakage) and casing pressure tests are completed as part of the ongoing casing integrity program. Wells identified with corrosion concerns are either pressure tested to ensure suitability for service, repaired, or taken out of steam service. Improved primary cementing practices for new wells enhance the ability to achieve and maintain cement tops at surface. However, if the cement quality is not adequate in the production casing, the well will be repaired or not utilized for CSS service. Wells that have cement tops near surface are topped up with bentonite during the first steam cycle.

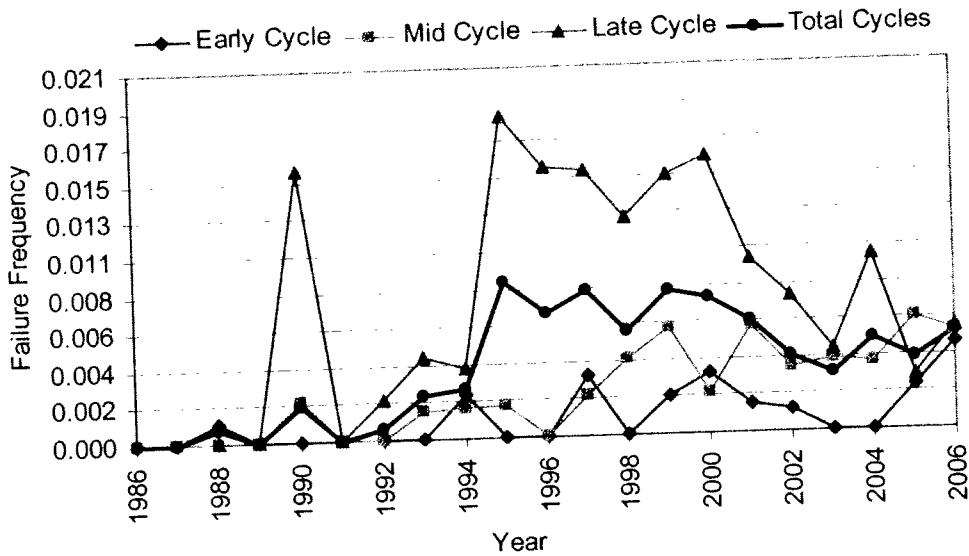
Figure 4: Primary Intermediate Commercial Failure Frequency Classified by Cycle

The primary intermediate failure frequency for L-80 or IK-55 casing design is provided below in Figure 4. The data is divided into early (1-4), mid (5-7), and late (8-12) cycle classifications, and within each classification failure frequency is determined based on the number of failures divided by the total number of wells within each classification.

As illustrated in Figure 4, the failure frequency for later cycle wells has been historically higher than for early and mid cycle wells, but has declined since 1995 due to the combination of removing wells with impaired casing from steam service and effectively controlling the wellbore environment.

As expected, the early and mid cycle failure frequency remains low, however it has increased since 2004. As a result of the T09 multi-well failure and the increasing failure frequency of early and mid cycle wells, Imperial Oil has initiated an investigation to review all aspects of the casing integrity process. From a systematic elimination of variables, data gathering efforts, and down-hole diagnostic work, the predominant failure mechanism has been identified as sulfide stress corrosion cracking (SSCC). Although the investigation is on-going, interim actions have been implemented as described below:

- Modifications to wellbore environment control standards (increased nitrogen purging)
- Enhancements to casing failure detection systems (integration of flow and passive seismic)
- Increased casing check frequency for 'upgraded commercial' design (metal-to-metal connections) to correspond with 'commercial new' design.
- Increased emergency response capabilities by increasing on-site hematite inventory from 100 to 350 tonnes, as well as the addition of a second pre-mix tank.

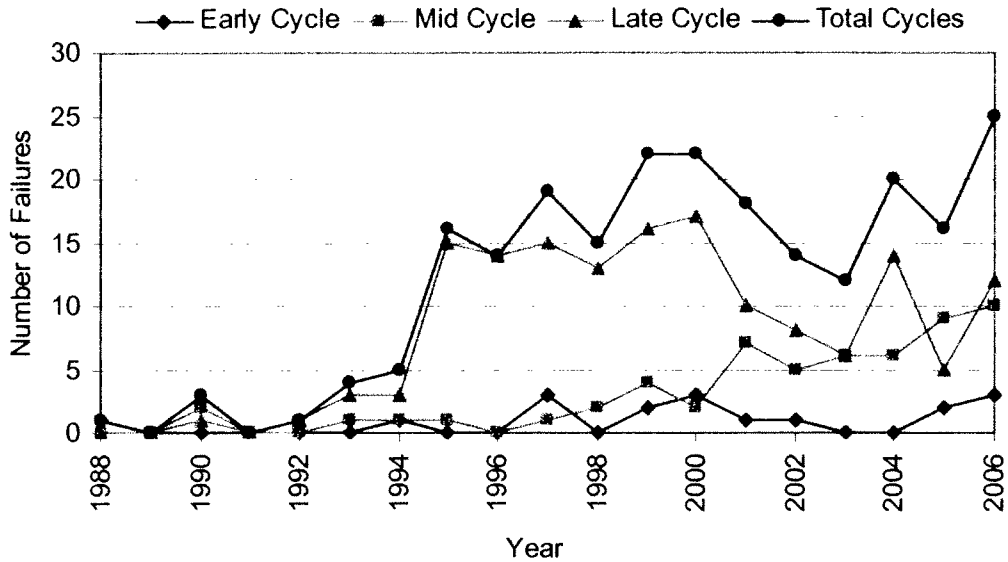
Figure 5: Primary Intermediate Commercial Failures Classified by Cycle

The number of primary intermediate casing failures in Cold Lake is summarized in Figure 5 below, and indicates that the number of early cycle failures has historically been lower than mid and late cycle failures.

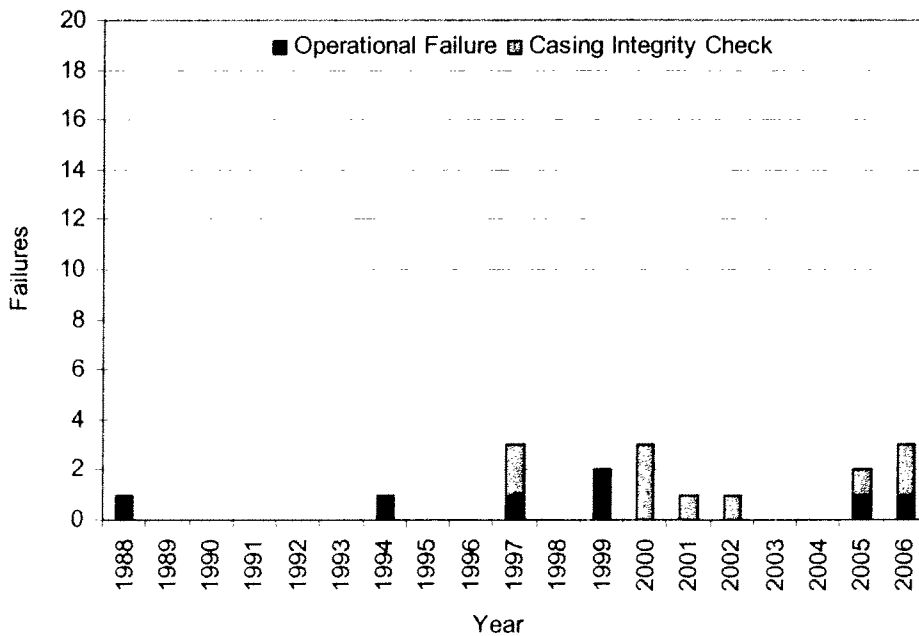
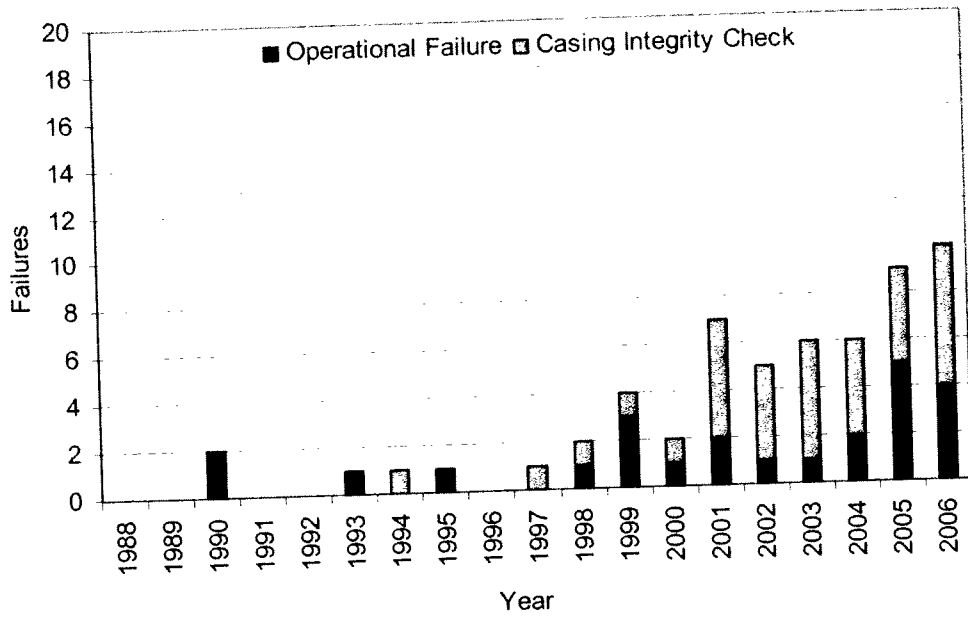
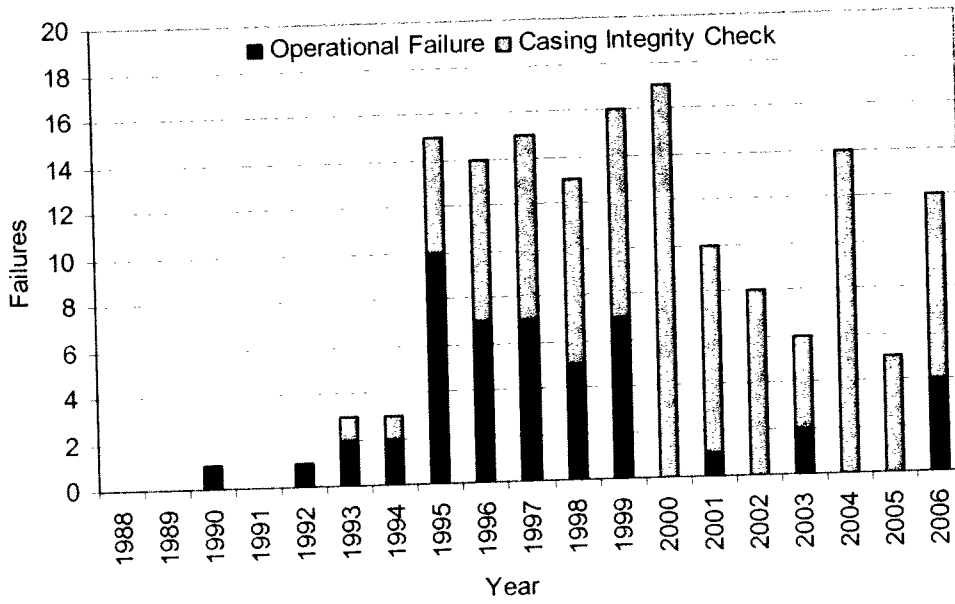
Failure detection method by cycle is displayed in Figures 6, 7 and 8. An operational failure is defined as a failure detected with DFP (Delta Flow & Pressure), Nitrogen Soak, or Passive Seismic. A casing integrity check failure is defined as a failure detected as part of the pre-steam casing integrity process. Although no correlation can be made for early cycle wells due to the limited data size, Figures 7 and 8 illustrate that the pre-steam casing integrity process detects a significant portion (approximately 70%) of the failures for mid and late cycles.

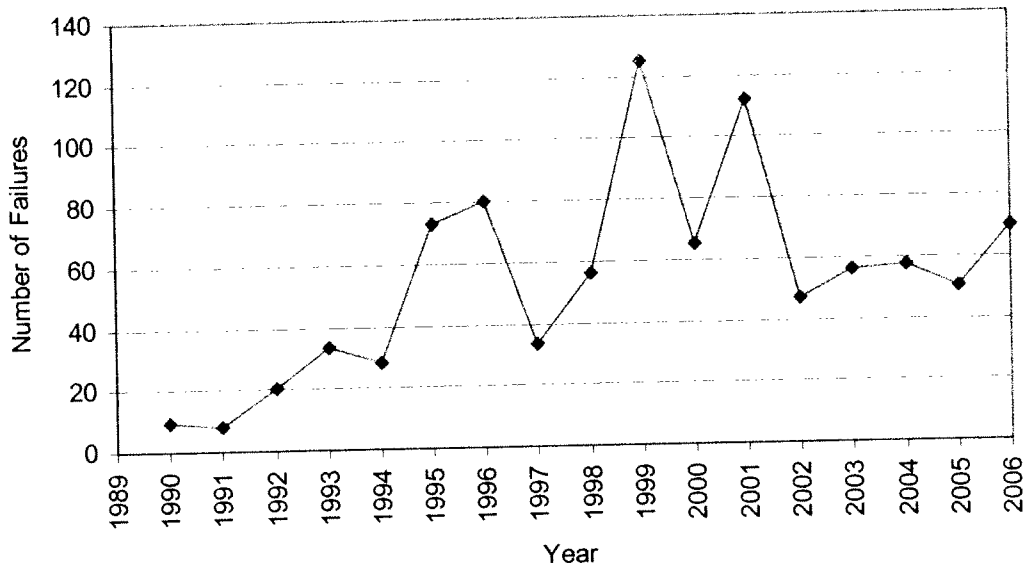
Figure 9: Clearwater Failures by Year

Formation movement is the primary mechanism for Clearwater (producing zone) casing failures. As a result of the CSS process, shear stresses develop which results in slip along structurally weak planes existing at the Clearwater / Grand Rapids interface. As this shear is localized, there is no impact on intermediate casing integrity. There is no evidence that Clearwater failures cause, or are related to other intermediate depth or near surface casing failures. Although there is no adverse environmental impact, serviceability of the well and thus Clearwater recovery, can be restricted. The number of Clearwater casing failures at Cold Lake is displayed in Figure 9 below. Details on the Clearwater casing failures are provided in Table 4.
